Analysis of Speed Indicator Device (SID) data for July/August 2022

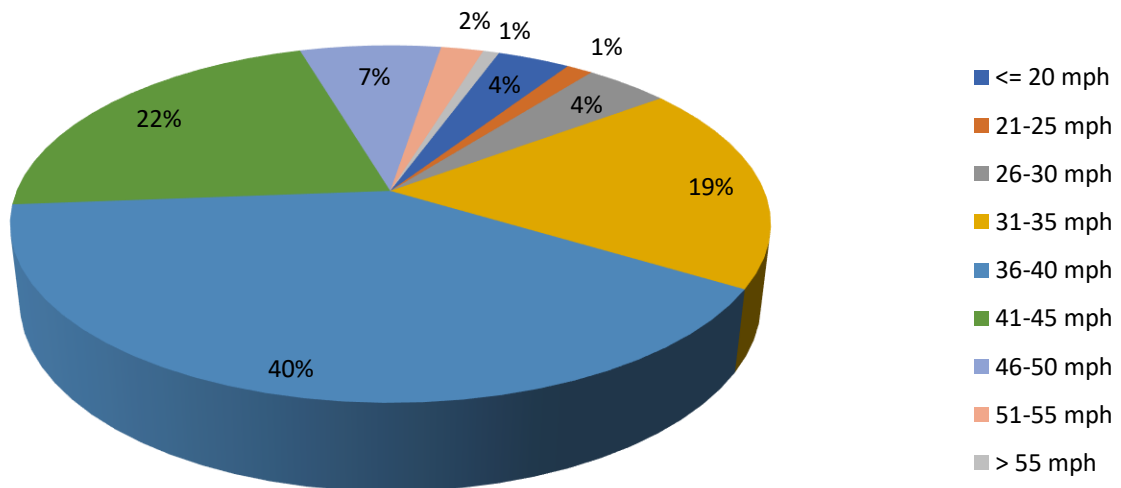
32% of vehicles were recorded as travelling in excess of the 40 mph limit with almost one in six (15%) recorded travelling at greater than 44 mph. The average speed was 38 mph.

The diagram, below, shows the distribution of vehicle speeds arriving from the Somersham direction:

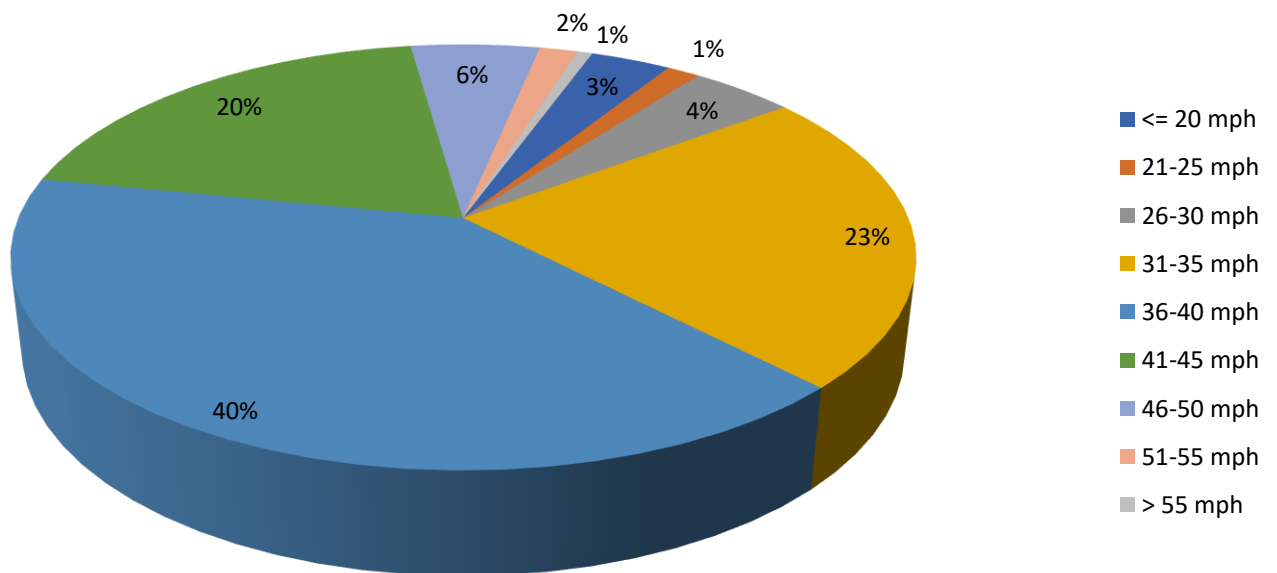
27% of vehicles were recorded travelling in excess of the 40 mph limit with almost one in six exceeding 43 mph. The average speed was 37 mph.

This diagram shows the distribution of vehicle speeds departing towards Somersham:
