## Analysis of Speed Indicator Device (SID) data for September 2022

The SID was located on Bluntisham Road just outside the “Colne” sign, facing towards Bluntisham, for 16 days between September 2<sup>nd</sup> & September 18<sup>th</sup> 2022. *(The SID collects data not only from approaching vehicles but also from those departing in the opposite direction; in the case of departing vehicles the speed is not displayed to the driver.)*

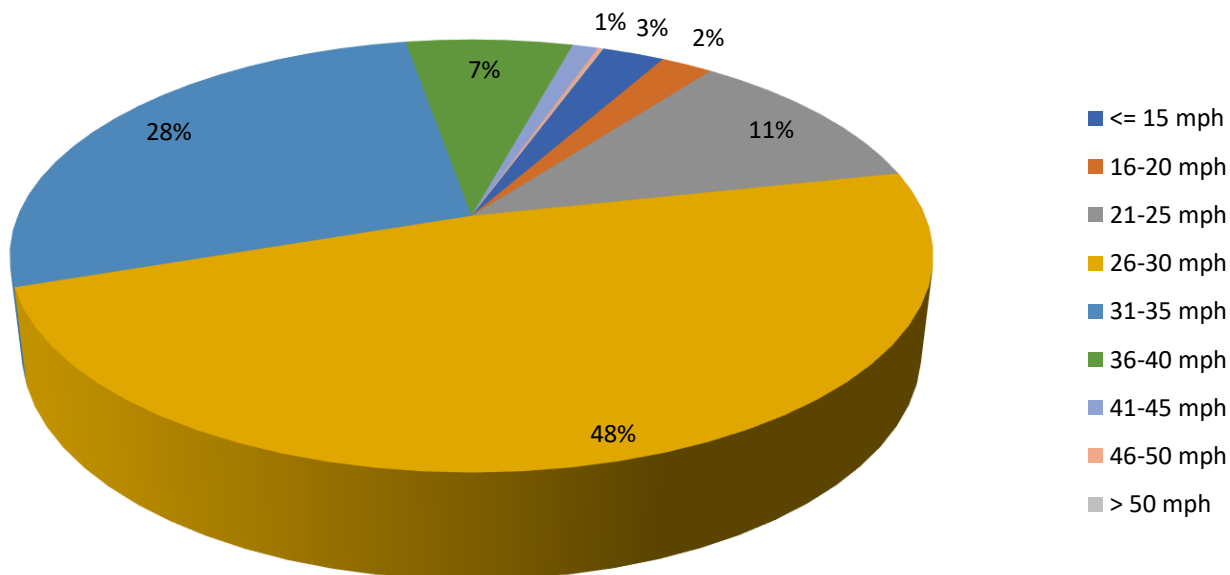
The diagram, below, shows the distribution of vehicle speeds arriving from Bluntisham:

36% of vehicles were recorded as travelling in excess of the 30 mph limit with almost one in six (15%) recorded travelling at a speed greater than 34 mph. The average speed was 29 mph.

These figures show an improvement on those recorded in May 2022 at the same location when 38% of vehicles were recorded as exceeding the limit. The average speed then was also 29 mph.

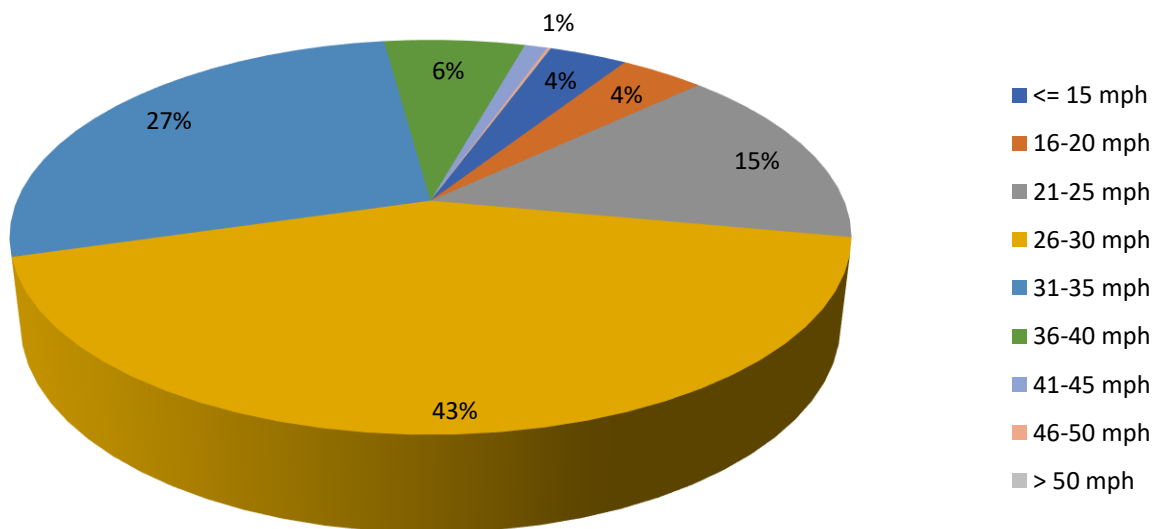
This diagram shows the distribution of vehicle speeds departing towards Bluntisham:

Over one-third (35%) of all vehicles were travelling in excess of the 30 mph limit with almost one in six exceeding 34 mph. The average speed was 28 mph.

These figures show a significant improvement over those of May 2022, with speed violations reducing from 39.8% to this month's 35%. The average speed has come down from 29 mph to 28 mph.
